The Chiani Suspension Bridge: A Complete Overhaul

Marco Petrangeli, Prof., INTEGRA S.r.l., Rome, Italy and Marcello Petrangeli, Eng. Tensacciai SpA Via F. Milano, Italy.
Contact: marco@integer.it

The paper presents the rehabilitation works carried out on the Chiani suspension bridge in Algeria. The bridge, designed by the French engineer Arnodin at the beginning of the last century, has a main span of 105 m and a mixed cable supporting system with a stayed deck portion near the towers. The bridge was designed and built before the similar Sidi M'Cid one in Constantine, Algeria. The strengthening works carried out on this bridge by the same authors during the 1990s was reported in *Structural Engineering International* (4/2000).⁴ Following the successful experience of the Sidi M'Cid bridge, the authors have been asked to engineer a complete overhaul of the Chiani bridge, a beautiful structure completely abandoned and closed to traffic because of its severe state of degradation. The works included the complete substitution of the suspension system, the widening of the superstructure with new pedestrian sidewalks moved out of the parapet girders and a new concrete deck to allow for u

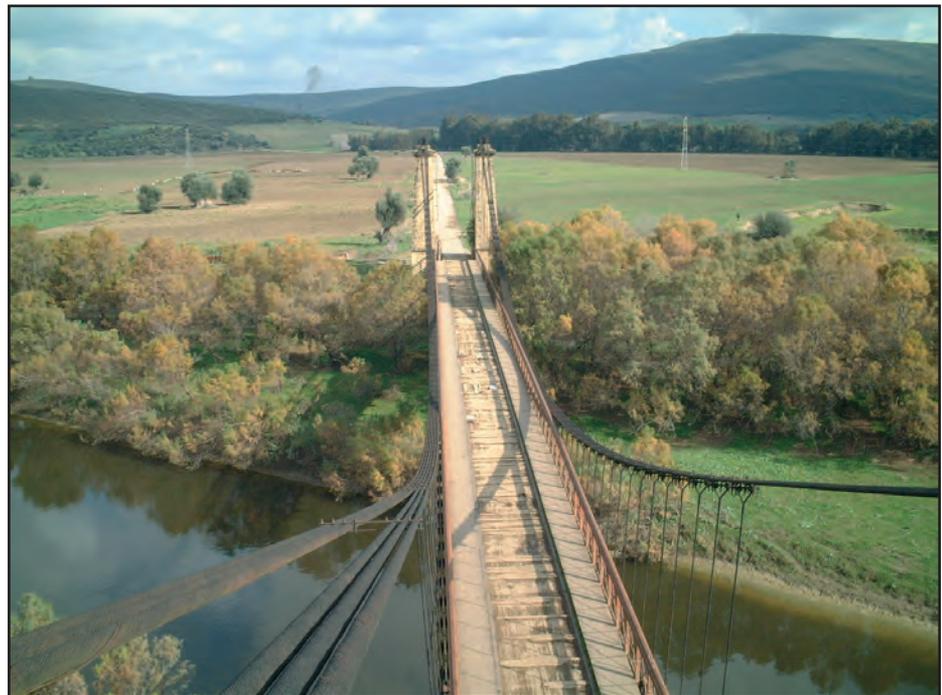
The Chiani Bridge (*Fig. 1*) is a small suspension bridge designed by the French engineer F. Arnodin at the beginning of the last century. The bridge spans over the Chiani River at the outskirts of the homonymous village, located near Annaba in northeastern Algeria. The bridge was built few years before

Fig. 1: The Chiani Bridge before the repair works

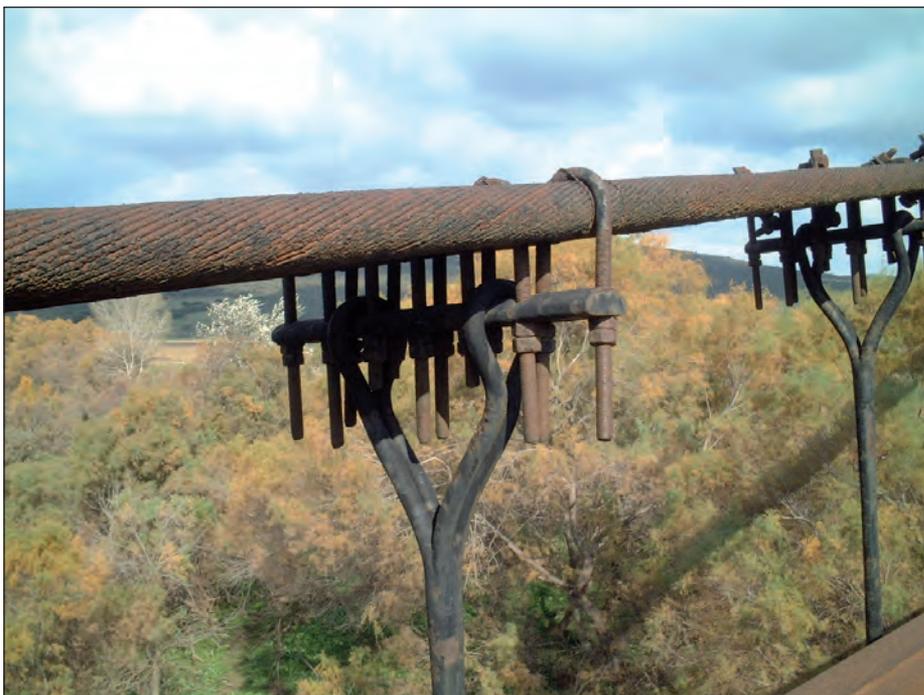
The bridge showed extensive signs of corrosion in the suspension and stay cables (*Fig. 3*) and in the deck stiffening girders and transverse beams. The wooden plank resting on the transverse beams was completely rotten leaving for the pedestrian crossing only two narrow kerbs made of corrugated steel.

The Chiani bridge was supported by two cables, each one made of six ropes of 75 mm diameter. The six ropes are not bundled together but run adjacent one to another and so rest over the saddle at pier top and at the anchorages. Each suspension rope was individually clamped with inverted U-shaped rods and nuts to small steel castings

Fig. 3: Cables, clamps and hangers

(Fig. 3) connected to the hangers made of 33 mm diameter rods. The 57 hangers each side of the deck are closely

All the elements of the suspension system showed severe signs of deterioration. Stays had quite a few broken wires hanging loose, cables were still locked but close inspection after their removal showed corrosion had reached the inner wires with localised pitting phenomena.

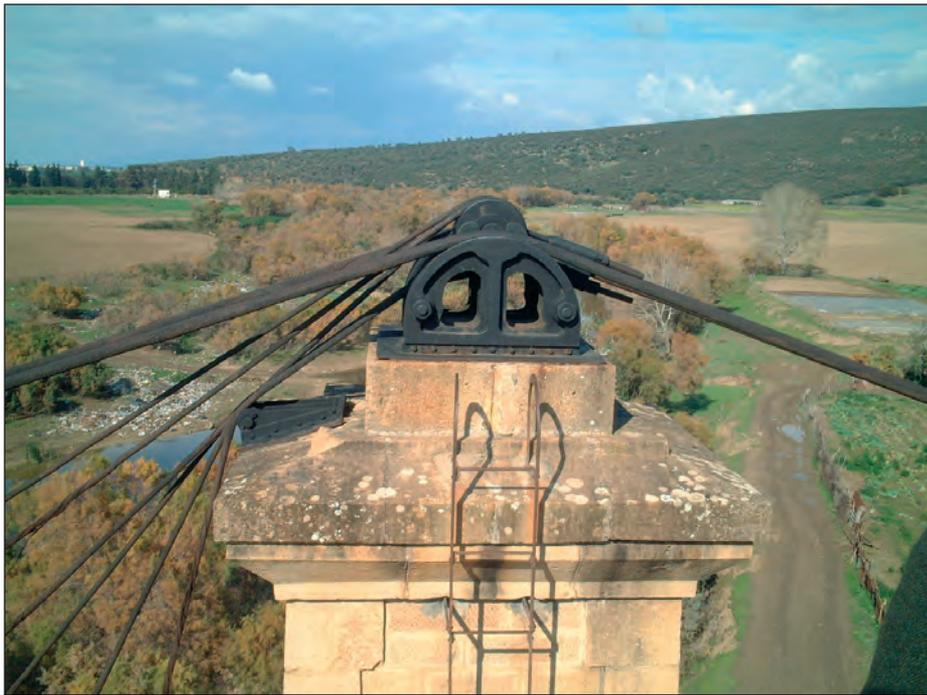
Twenty metres each side of the towers the deck was supported by six plus six stays made of 35 mm diameter ropes. These six stays were made of three ropes looping around three pulleys at the saddles. Their force was balanced by a backstay made of a 42 mm diameter rope (Fig. 4). The stays are anchored to stiffening I-beams that run beneath the stayed portion of the deck under the parapet girders. The horizontal force component of the stays is balanced by two ropes (traction ropes), running below the deck along the suspended part and connecting the above-mentioned I-beams at the two sides of the bridge. This configuration allows the deck to swing longitudinally because the horizontal stay component is self-equilibrated and the deck does not push against the abutments (towers).

The saddles could slide on rollers (Fig. 4); this mechanism, although showing extensive sign of deterioration, must have been still effective at the time of rehabilitation judging from the perfect condition of the stiff masonry towers.

Fig. 4: The old saddles

The old saddles have been encased in a steel box, cement grouted once the

old cables and stays were removed. The new saddles are placed on top of these encasings on steel-teflon bearing pads that allow longitudinal displacements.

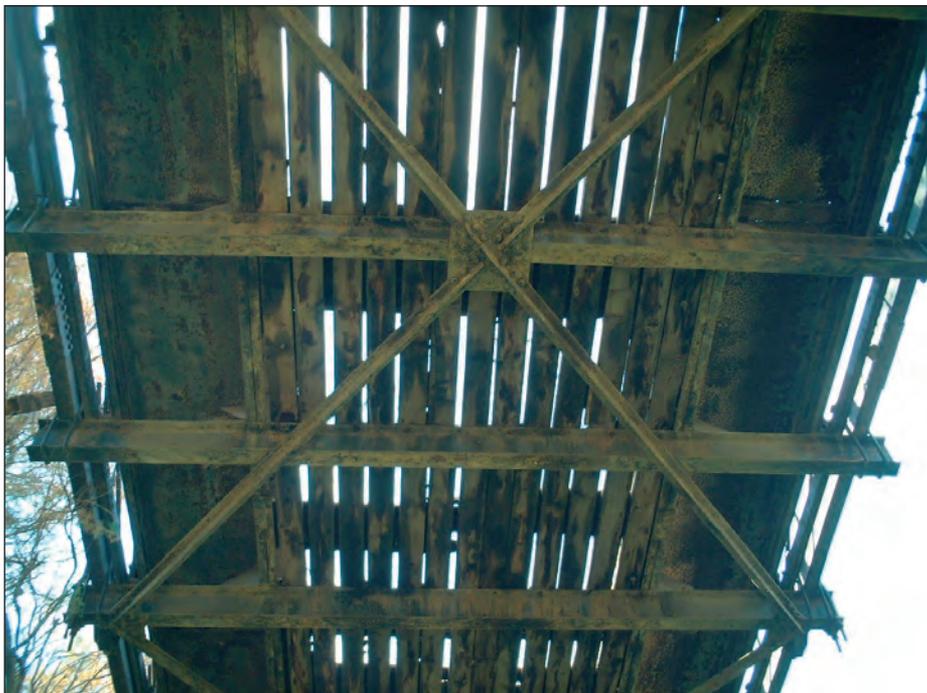
directly supported by the hangers. Both elements showed extensive but still superficial corrosion. The running surface of the deck was made of wooden planks and was in a very poor state (Fig. 5), falling apart and leaving wide openings so that the bridge was officially closed to traffic, although still providing factual crossing for pedestrians, small motorbikes and herds along two steel clad kerbs running besides the two parapet girders.

Fig. 5: The existing deck

In order to open the bridge to vehicular traffic, it was decided to cast a concrete slab on top of the transverse beams in

Thickness of the slab has been kept to a minimum (140 mm) so as to reduce its weight. The slab was cast onto corrugated steel sheeting for increased punching and bending resistance. Still, the new concrete slab provided 100% increase of the deck self weight with respect to the original configuration.

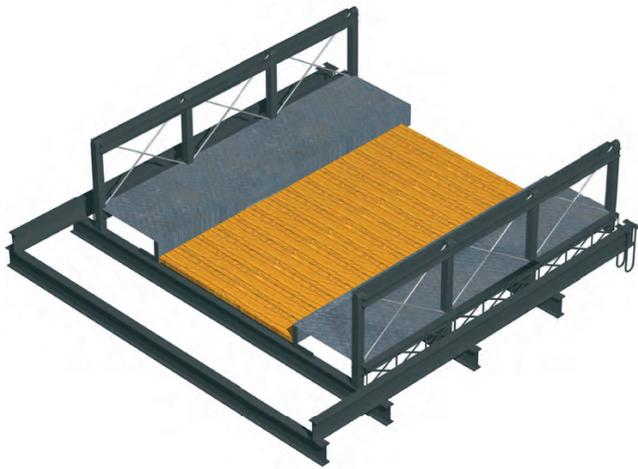
In order to allow for vehicular traffic to run onto the new deck, two other aspects had to be addressed, namely: transverse beams had to be strengthened and kerbs displaced (Fig. 6) to make place for a single lane carriage-way in between the parapet girders (see also Ref. [6]).

Fig. 6: Deck three-dimensional view. Before (left) and after

Strengthening of the transverse beam was obtained by welding an additional plate onto the bottom flanges and stud connectors on the top ones so as to obtain composite action with the concrete slab.

Sidewalks were moved outside of the parapet girders. This displacement required the transverse beams to be extended with additional steel plates bolted onto the transverse beam web so as to support the new pedestrian corridors positioned in between the parapet girders and the new hangers.

The hangers had also to be displaced half a metre outwards thus swinging the suspension cables from the slightly inward original position, to their new position, 3° outwards.

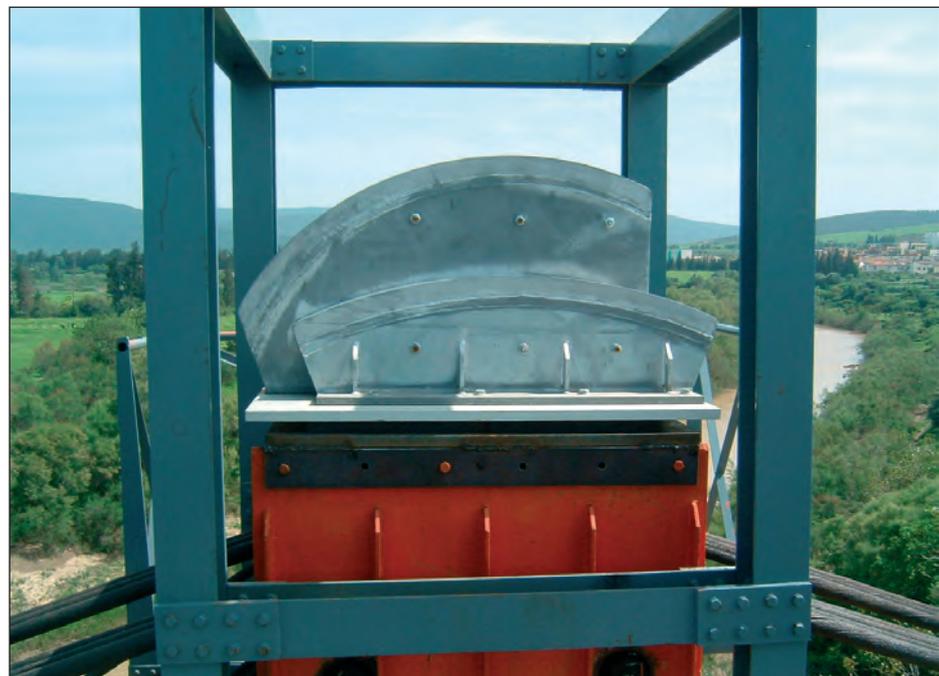
The key elements of the new system are the new saddles (Fig. 7). These elements were designed following a philosophy developed for larger bridges by William Brown (1928–2005) where the saddles are an assemblage of smaller components made of rolled and welded plates instead of being made of a single casting.

Fig. 7: The new saddles

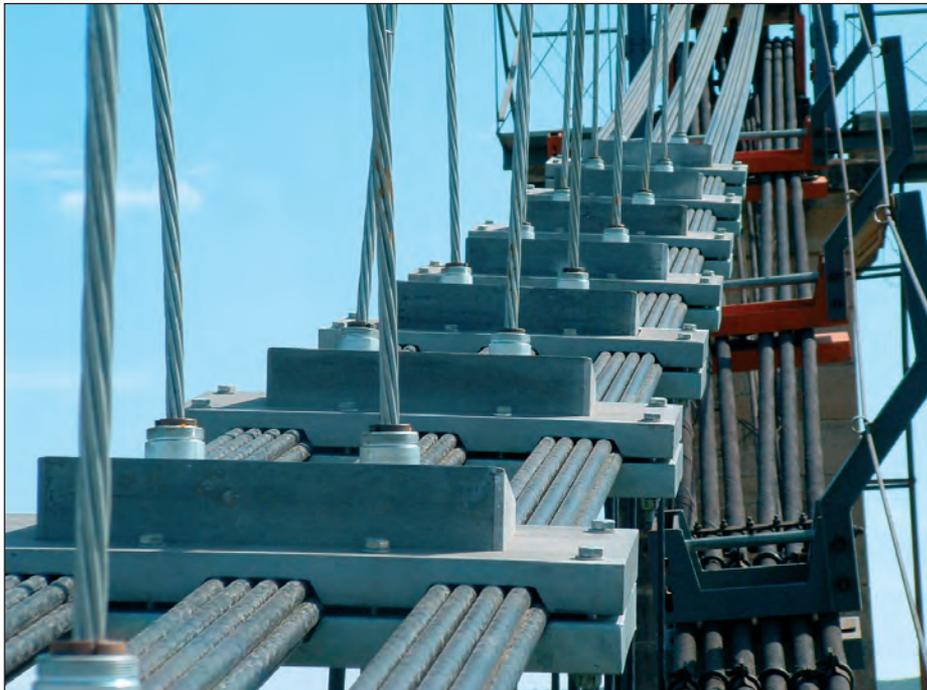
Main suspension cables are made of epoxy-coated prestressing strand arranged in three ropes of 13 strands on each side. Clamps are made of two parallelepiped castings bolted together. Hangers are made of two strands each fixed to the clamps with standard monostrand prestressing anchorages. Between hangers and deck, a tensioning rod has been interposed to allow for easier and finer tensioning in the last project stages.

All the suspension system components (Fig. 9) were therefore made in Italy and shipped to Algeria together with the epoxy-coated prestressing strands.

Fig. 9: The clamps

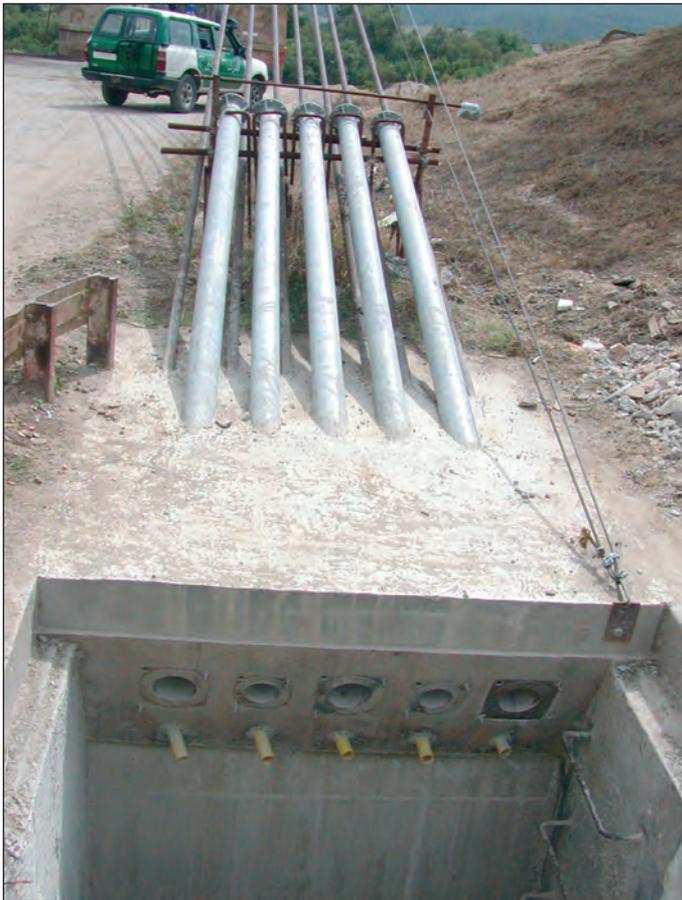
The new suspension cables and stays were anchored in cast *in situ* reinforced concrete blocks connected to the existing anchorages (Fig. 10). These anchorages were made of lean concrete, cast inside pits bored in the rocky ground.

The original cables were deviated at the entrance by steel clad concrete saddles and anchored vertically inside these pits.

The anchorage chambers were large enough to make room for the new reinforced concrete castings. The additional weight of the new anchorage blocks, firmly connected to the existing ones by means of reinforcing bars drilled and grouted into it, provided sufficient strength for the increased weight of the suspension bridge.

Fig. 10: The new anchorages cast inside the existing ones

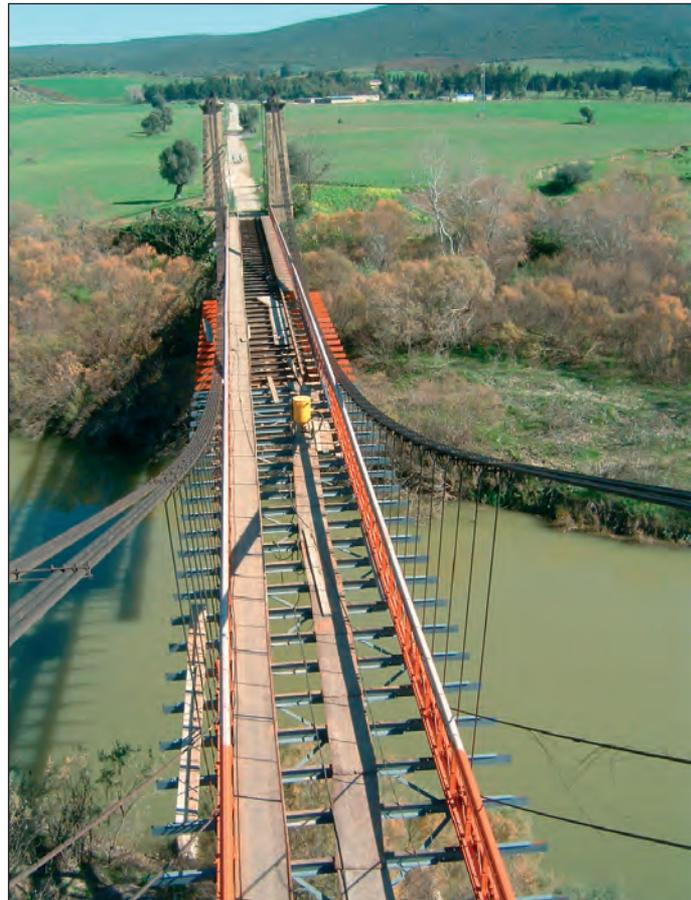
The works commenced with the complete removal of the wooden deck planks and sandblasting of the existing steel deck components. The superstructure was then reinforced by welding additional plates to the transverse beams and parapet girder upper chords and widened by bolting extensions to each transverse beam (Fig. 11). A total of 2,5 kN/m of structural steel was added to the deck during this stage. Corrosion protection, by means of epoxy primer coating, was then applied to the whole of the structure.

Fig. 11: Strengthening and widening the transverse beams

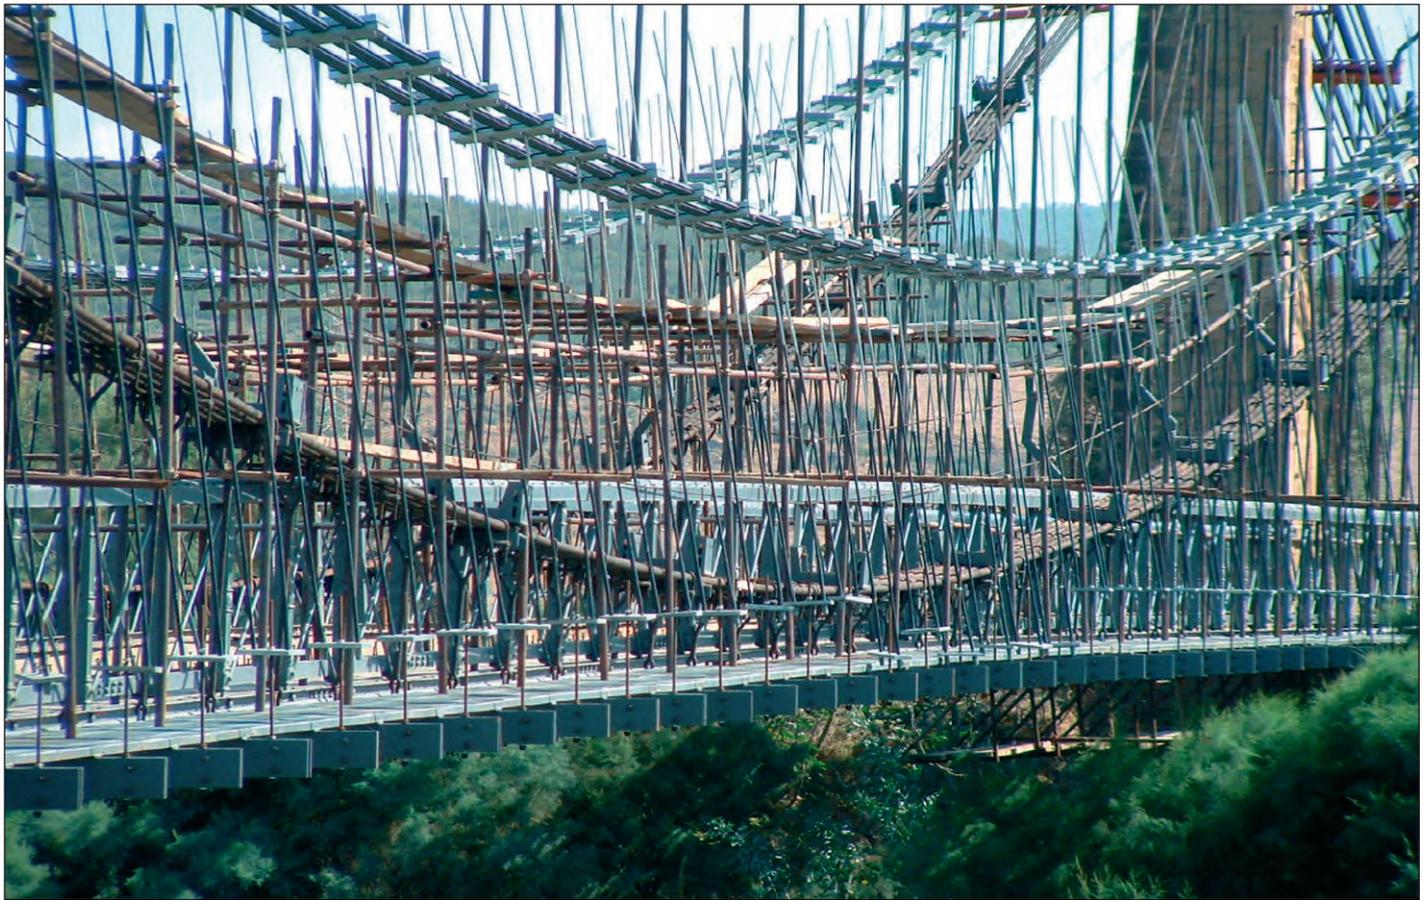
Replacement of the suspension system followed. The new cables were spun across one strand at the time (78 strands) using the catwalks erected on the existing cables. The freestanding position of the new cables was, at midspan, 3,5 m *circa* above the deck and therefore 3 m higher than the old cables (Fig. 12). This choice allowed,

after loading the new cables, a minimum clearance of 2,2 m at midspan for pedestrians.

Fig. 12: The two suspension systems before the load transfer

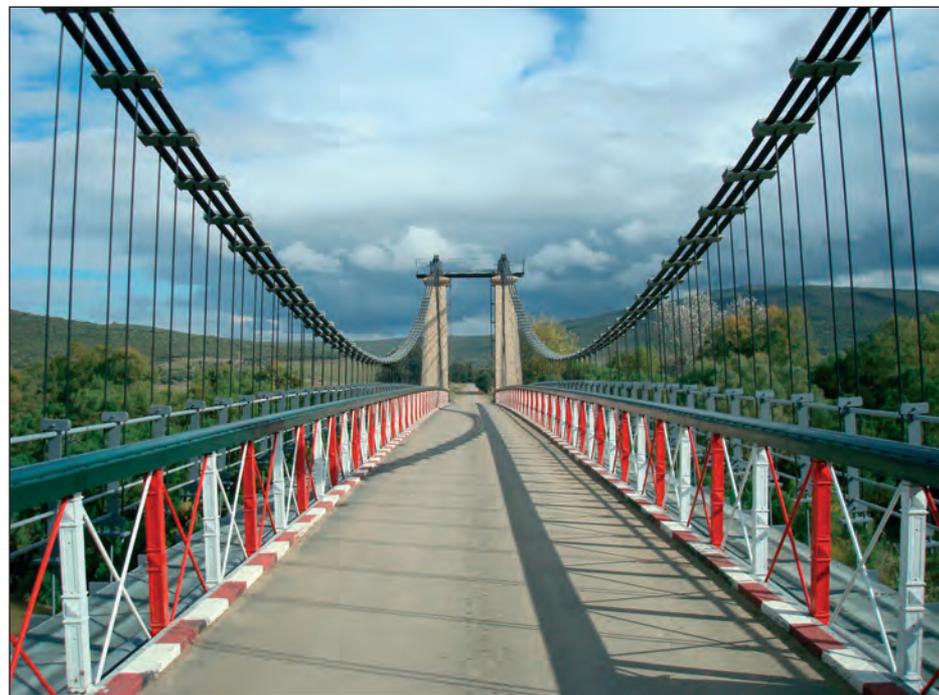
Finishing works then followed, with a 30 mm bituminous wearing course cast on the deck slab and the external railing erected using the hangers as supports (Figs. 15 and 16).

Fig. 15: The new Chiani bridge platform

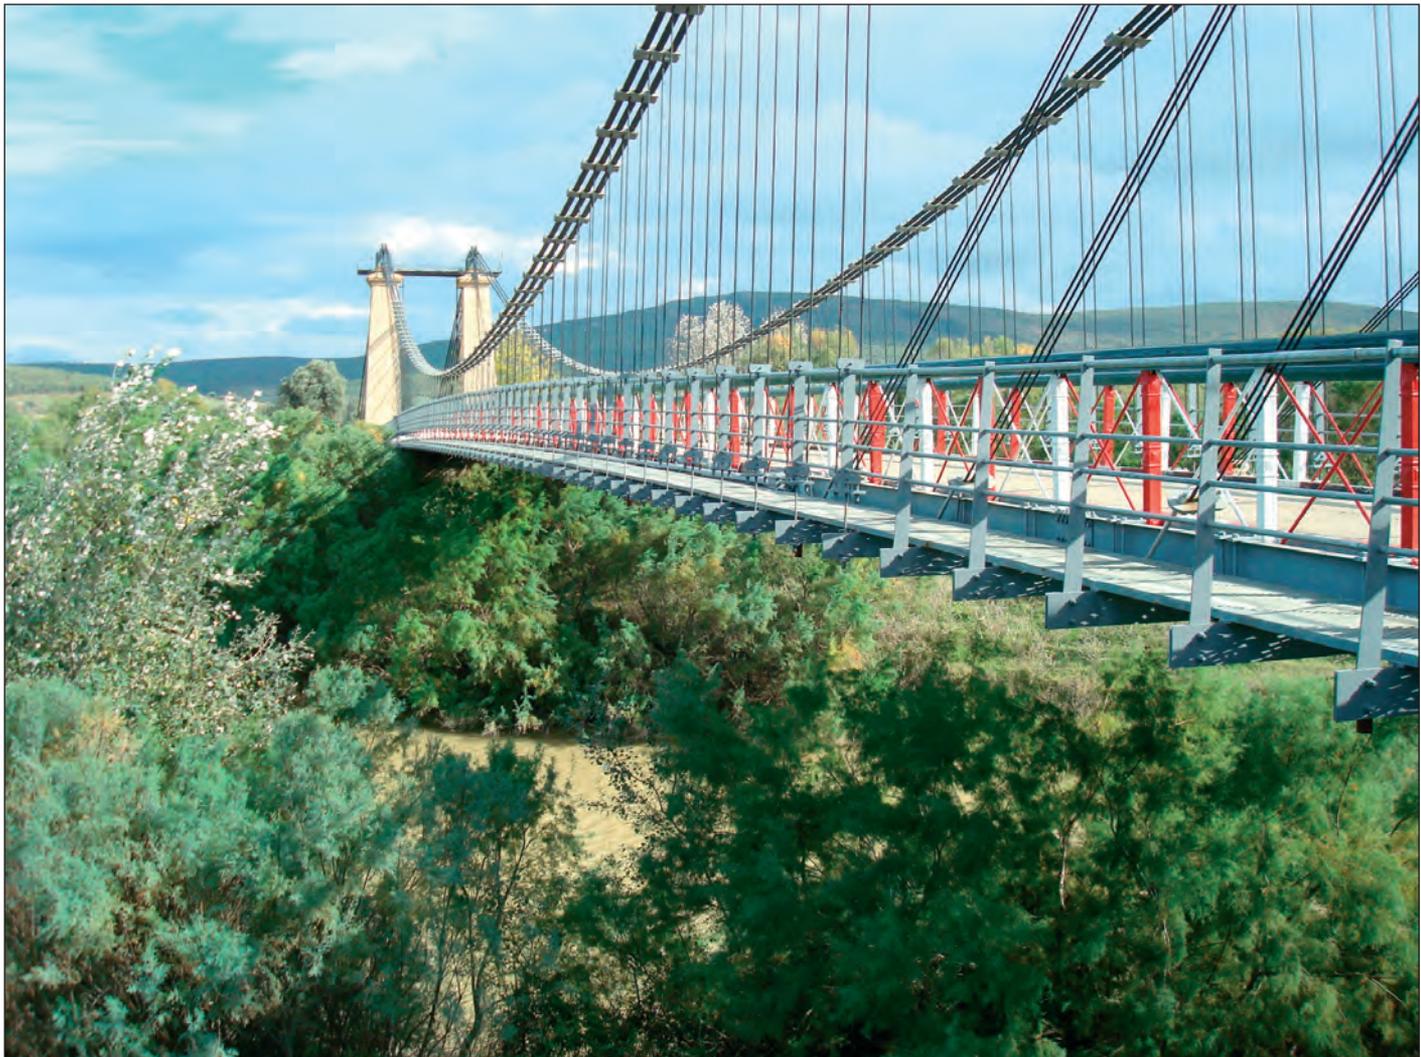
Fig. 16: The Chiani bridge
