# The Chiani suspension Bridge: a complete overhaul

The paper presents the total rehabilitation of the Chiani suspension bridge in Algeria. The bridge, designed by the French engineer Arnodin at the beginning of the last century span 105 metres using a mixed cable supporting system with a stayed deck portion near the towers. The bridge was designed and built before the similar Sidi M'Cit one in Constantine, Algeria.

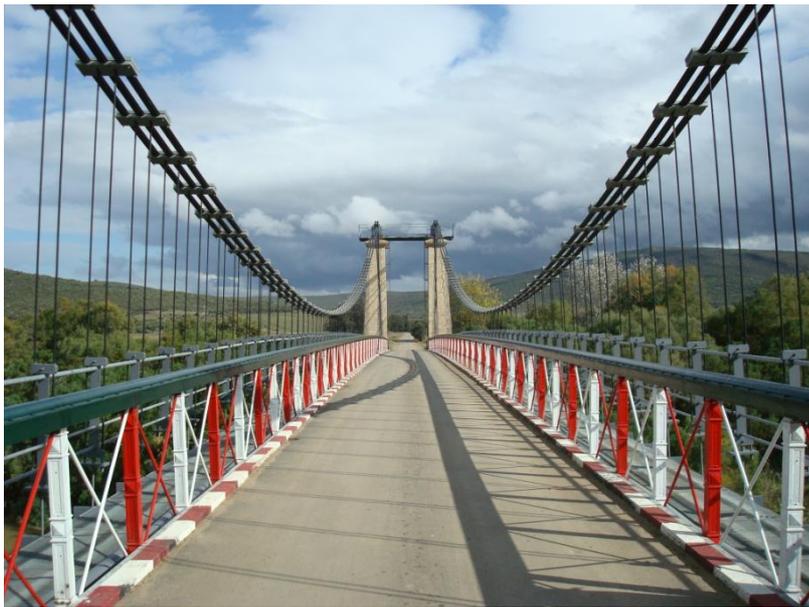
In order to open the bridge to vehicular traffic it was decided to cast a concrete slab on top of the transverse beams in between the two parapet girders. While providing a firm surface for vehicular traffic the slab would also strengthen significantly the bending and axial behaviour of the superstructure. Thickness of the slab has been kept to a minimum (14 cm) so as to reduce its weight. The slab was cast onto corrugated steel sheeting for increased punching and bending resistance. Still, the new concrete slab made for an hundred percent increase of the deck self weight with

respect to the original configuration.

In order to allow for vehicular traffic to run onto the new deck, two other aspects had to be addressed, namely: transverse beams had to be strengthened and kerbs displaced to make place for a single lane carriageway in between the parapet girders. Strengthening of the transverse beams was obtained by welding additional plates onto the bottom flanges and stud connectors on the top ones so as to obtain composite action with the concrete slab.

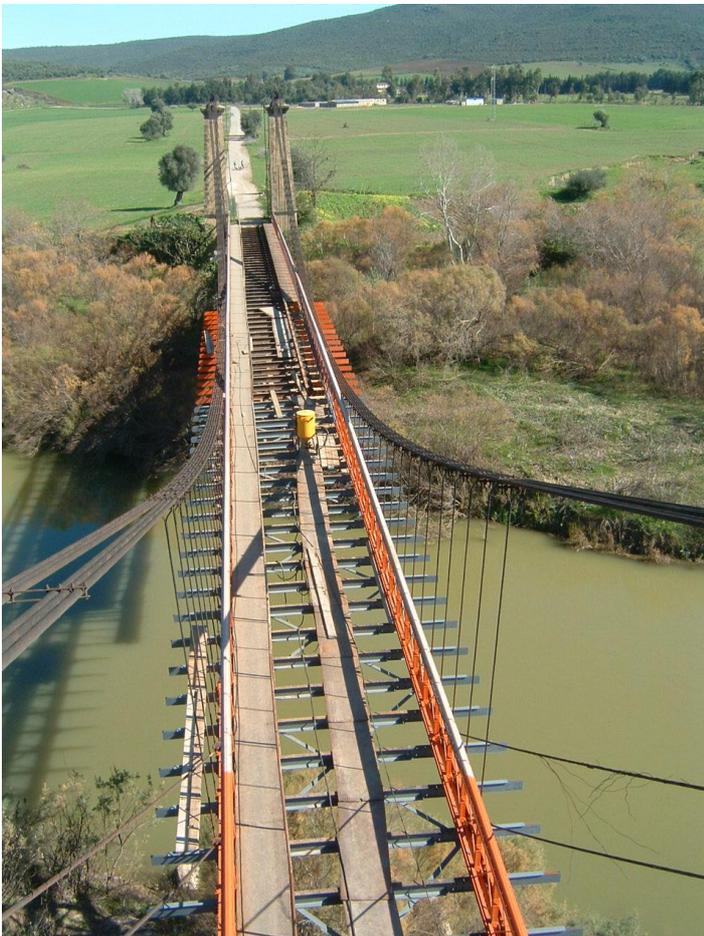
*Fig. 1 – The bridge during the deck rehabilitation*

The bridge showed extensive signs of corrosion in the suspension and stay cables and in the deck stiffening girders and transverse beams. The deck running surface, originally provided by wooden planks resting on the steel transverse beams was completely rotten leaving for the pedestrian crossing only two steel plated narrow kerbs adjacent to the parapet truss girders.

All the elements of the suspension system showed severe signs of deterioration. Stays had quite a few broken wires hanging loose, cables were still locked but close inspection after their removal showed corrosion had reached the inner wires with localised pitting phenomena.

The works commenced with the complete removal of the wooden deck planks and sandblasting of the existing steel deck components. The steel deck was then reinforced by welding the additional plates and widened by bolting extensions to each transverse beam (Fig. 1). A total of 2.5 kN/m of structural steel was added to the superstructure during this stage. Corrosion protection was then applied to the whole of the structure.

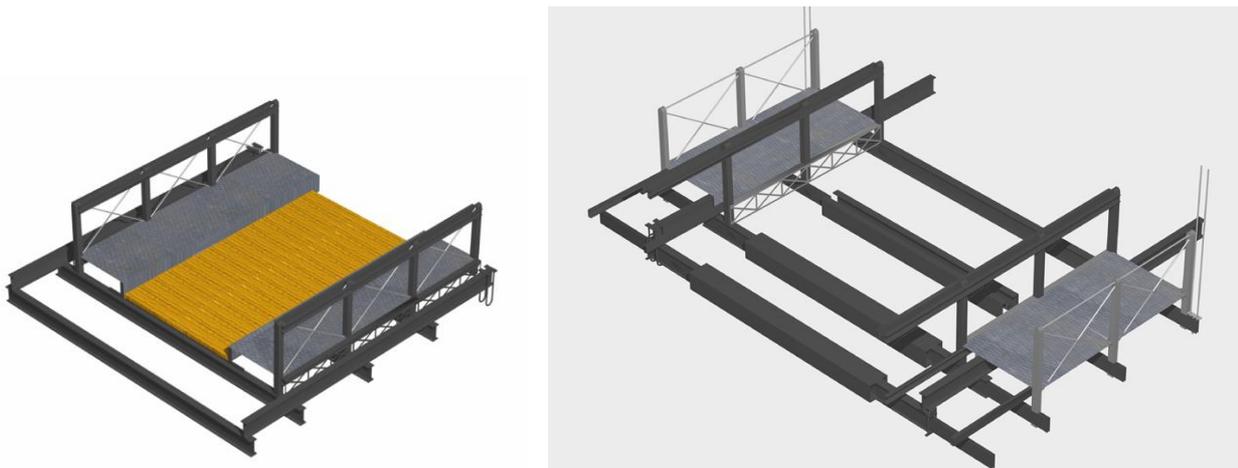
Fig. 2 – Deck 3D view. Before (left) and after widening

In order to allow for vehicular traffic to run onto the new deck, two other aspects had to be addressed, namely: transverse beams had to be strengthened and kerbs displaced (Fig. 2) to make place for a single lane carriageway in between the parapet girders (see also [7]). Strengthening of the transverse beams was obtained by welding additional plates onto the bottom flanges and stud connectors on the top ones so as to obtain composite action with the concrete slab. Sidewalks were moved outside of the parapet girders. This displacement required the transverse beams to be extended with additional steel plates bolted onto their webs so as to support the new pedestrian corridors positioned in between the parapet girders and the new hangers. The hangers had also to be displaced half a metre outwards thus swinging the suspension cables from the slightly inward original position, to their new, 3° outwards, position.

Since deck concreting displaced the section centroid downwards, while strengthening the transverse beams, additional plates were also welded onto the upper chords of the parapet truss girders increasing the upper chord lateral and torsional stiffness and the girders buckling resistance.

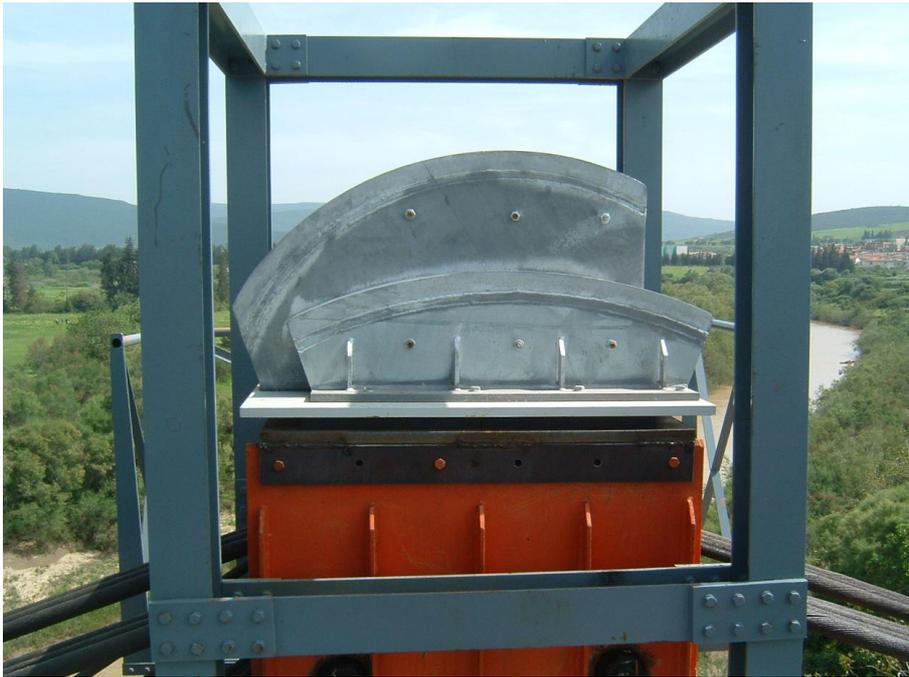
*Fig. 3 - The new saddles*

The key elements of the new system are the new saddles (Fig. 3). These element were designed

following a philosophy developed for larger bridges by William Brown (1928-2005) were the saddles are an assemblage of smaller components made of rolled and welded plates instead of being made of a single casting. The old saddles have been encased in a steel box, cement grouted once the old cables and stays were removed. The new saddles are placed on top of these encasings on Steel-Teflon bearing pads that allow longitudinal displacements.

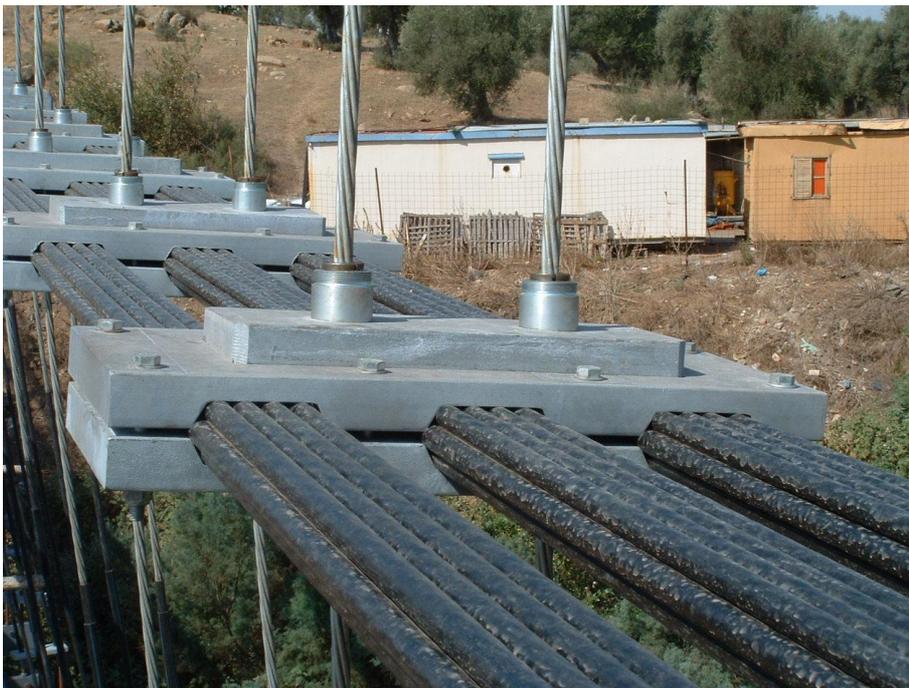
*Fig. 4 - The new cables, clamps and hangers*

Main suspension cables are made of epoxy coated prestressing strand arranged in 3 ropes of 13 strands on each side. Clamps, kept at their original spacing, are made of two parallelepiped castings bolted together. Hangers are made of two strands each fixed to the camps with standard mono-strand prestressing anchorages. Between hangers and transverse beams, high strength treated bars are interposed to allow for easier and finer final tensioning.

force component of the hangers pull that increases toward the towers up to 25% of the vertical force. The tests showed a surprisingly good capability of the clamps to resist tangential forces. Short term resistance was, on average, 50% of the clamping force (8 D12mm bolts each clamp). No significant reduction of this resistance could be detected for long term load application although some loss can be expected after prolonged exposure to the Algerian sun. Still, the design maximum tangential force for the clamps (5 kN) is less than 10% of the resistance (50 kN) found in the laboratory on a prototype, clamping only 1 cable out of 3 with 4 bolts, instead of 2 cables and 8 bolts of the actual clamp. All the suspension system components were therefore made in Italy and shipped to Algeria together with the epoxy coated prestressing strands.

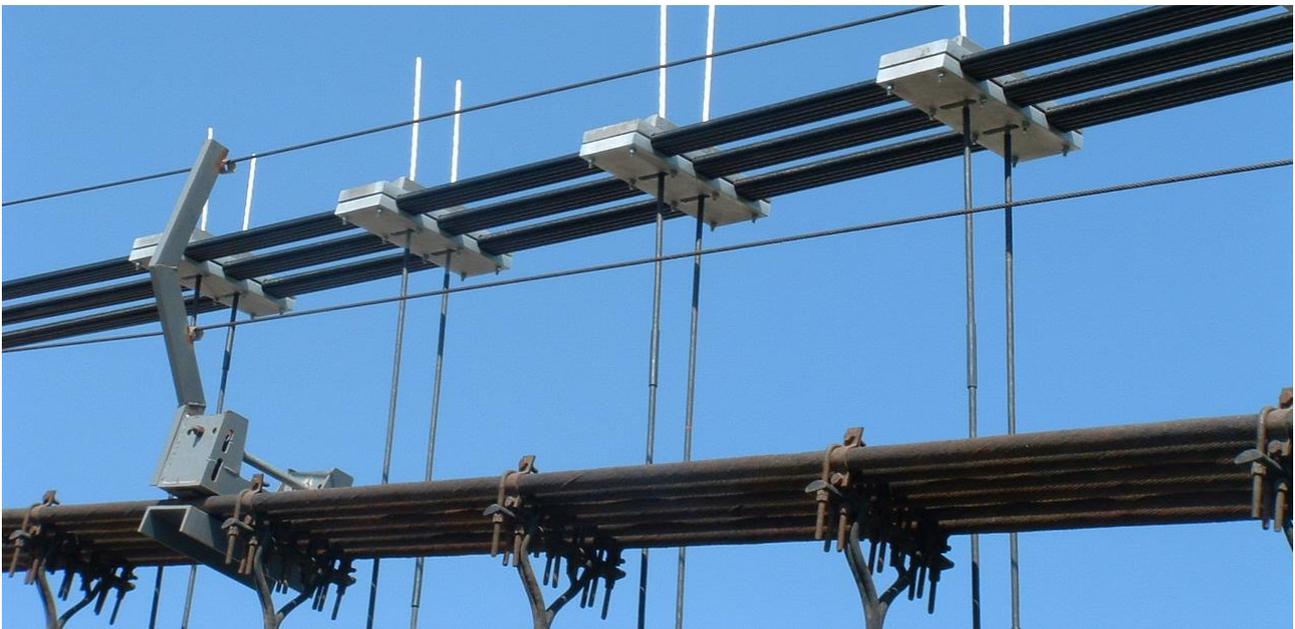
*Fig. 5 – The two suspension systems before the load transfer*

Replacement of the suspension system followed. The new cables were spun across one strand at the time (78 strands) using the catwalks erected on the existing cables. The free standing position of the new cables was, at midspan, 3.5 metre circa above the deck and therefore 3 metres higher than the old cables (Fig. 5). This choice allowed, after loading the new cables, to leave a minimum 2.2 metre clearance at midspan along the pedestrian walkways.

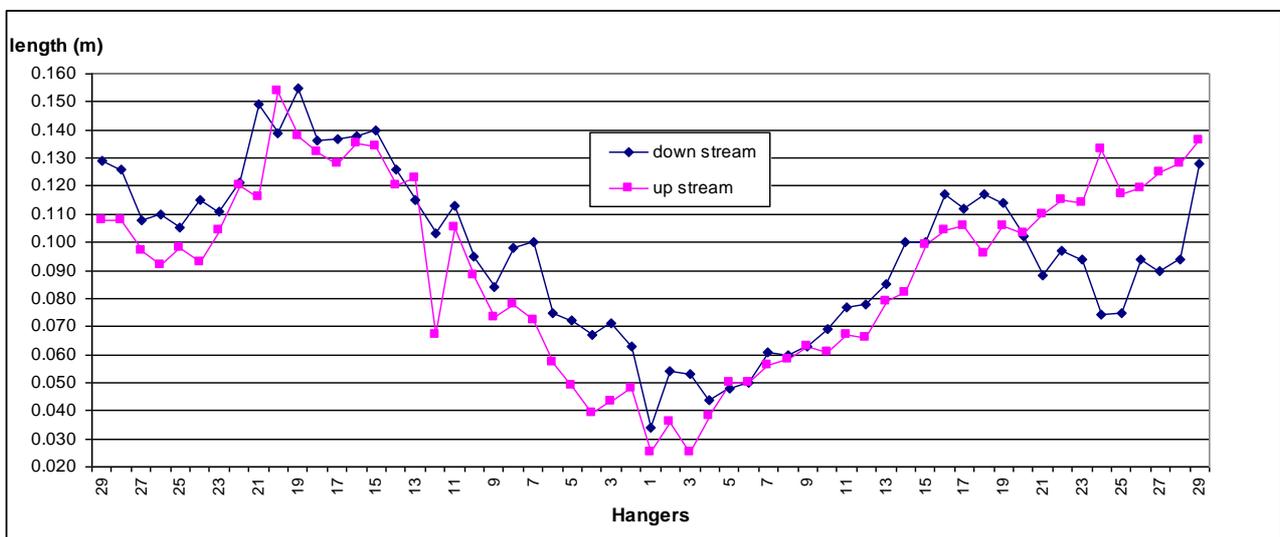
Fig. 6 – Hanger's length difference between design and measured after first tensioning

A first tensioning of the new system was then carried out with the new hangers shortened to a given length so as to take over roughly 50% of the deck weight. This operation was rather unusual since the stay technology and equipment used for the new suspension system are designed for stiffer configurations and higher loads. Tensioning started from the midspan hangers, shortened by 50cm circa, with a tensioning force of few kilonewtons. Tensioning then moved symmetrically towards the towers with the main cables gaining tension and stiffness thus simplifying the tensioning operations. Because this first tensioning took place after a prolonged summer stop due to environmental and minor technical adjustments, significant errors were committed when shortening (tensioning) the hangers to the predefined length. A plot of this error is shown in Fig. 6. Hanger length was topographically measured after first tensioning. Since tension in the hangers was negligible, topographically measured length was a fair estimate of the actual unstretched one.

Error in hanger tensioning could be easily verified by manually checking the tension in the hangers. According to the above graph, few hangers were almost slack, other significantly stiffer than the others. Nonetheless, the bridge deck proved to be sufficiently strong and flexible to withstand the uneven load distribution resulting after the first hanger tensioning. Given the very light deck configuration and strength reserve of both deck and hangers, it was therefore decided to proceed with the next phase leaving the correction of the first tensioning to a later stage.

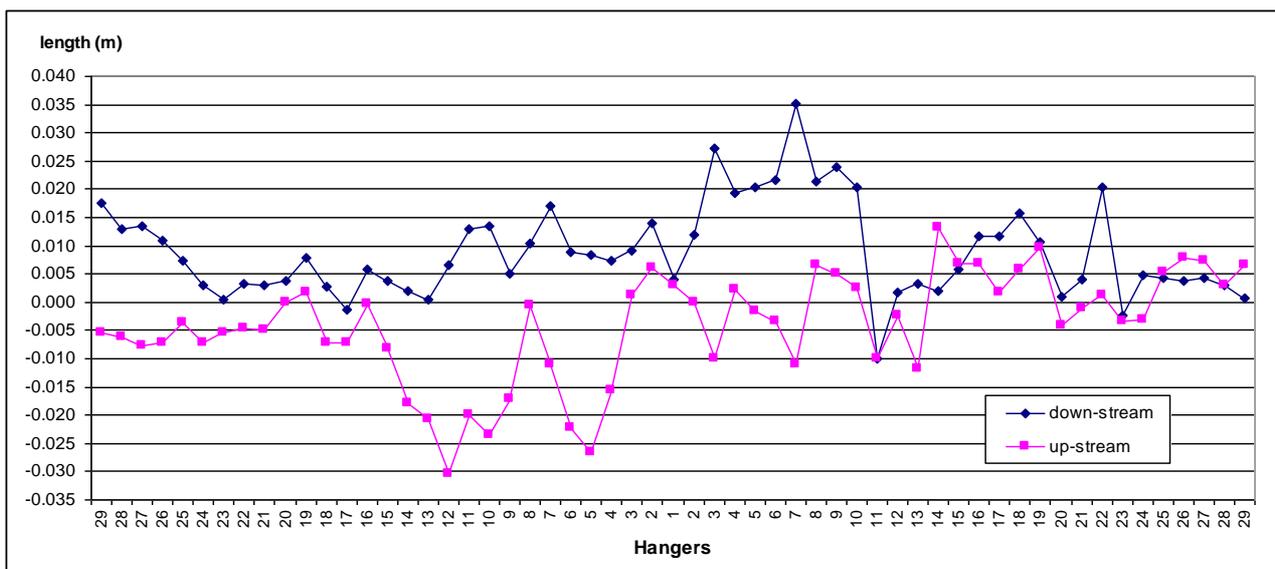
Fig. 7 – Hanger’s length difference between design and measured after second tensioning

After the second tensioning, strand anchorages up in the clamps were pushed to lock, the strands cut to measure and the anchorages greased and closed with their metallic cap. After second tensioning, the error between design and measured value reduced significantly as shown in Fig. 7. Following the second tensioning, stays were replaced, two at a time, with the new ones made of the same strands used for the main suspension cables. Contrary to hanger tensioning, carried out under geometry (length) control, stays have been tensioned to predefined force values.

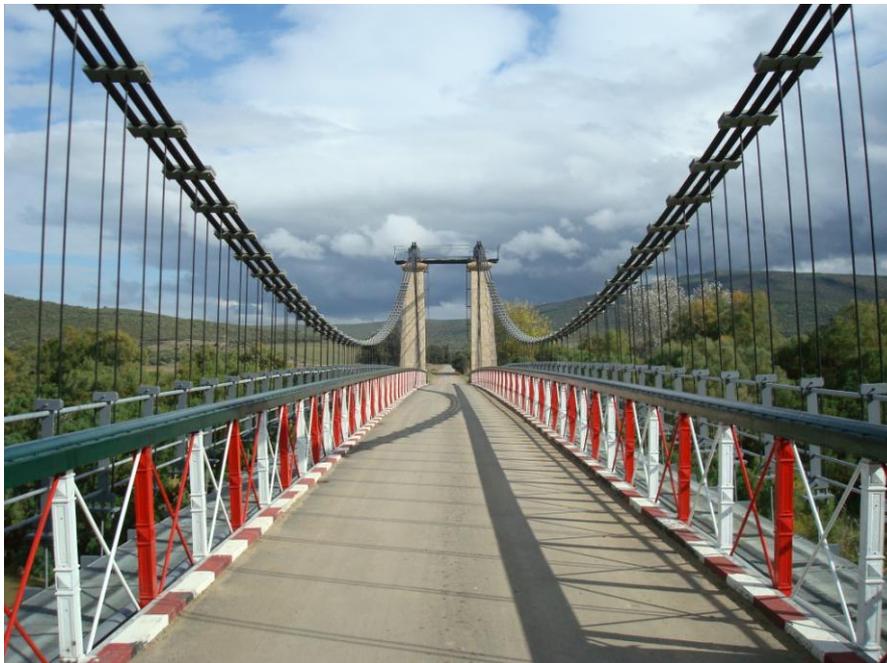
- Concreting of the deck is often a simple and efficient system to strengthen the bridge provided the towers and the foundations have enough strength reserves. Additional weight can be

accounted for when designing the new suspension system thus obtaining a stiffer structure (via the increased tension in the cables) but also a tougher and more ductile response of the deck under the increased live loading of today traffic.
