# Rescuing the Sidi Rached Bridge

## Summary

The Sidi Rached Bridge, built in the early 20th century, crosses the deep Rhumel canyon in the centre of Constantine, Algeria. The bridge is made of 27 arches, with spans varying from 12 to the 68 metre of the main arch crossing the Rhumel 102 metres above the riverbed. The bridge is a famous city landmark and one of the main cultural heritage of Algeria as well as the largest masonry structure of this type in Africa. The 8 spans on the right bank have been suffering for over 50 years, from intermitting slope instability. The problem has been addressed and temporarily solved few times now. All the attempts tried to anchors the pier foundations to the bedrock while reducing the cause of soil instability with drainages. During the '70, the downhill displacement of the abutment spiked and the structure had to be disconnected severing the first arcade and replacing it with a simply supported buffer steel girder. After 30 years of relative calm, the landslide peaked again in 2008 causing severe damage to all the piers on the right bank and the near collapse of one arch. A new campaign of assessment, reconstruction and strengthening has ther

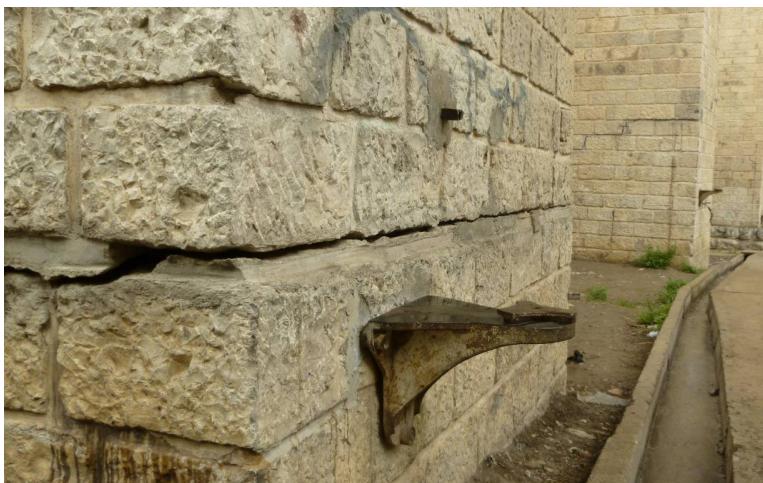
*Fig. 4 : Wide flexural cracks at piers bases*

new damages seemed to differ from the previous ones since wide new cracks were opening while previous damages could not be detected. The cause of the damage is obviously the slope instability, but the effect of this movement onto the structure was not clear enough. The cracks and displacements were so big that it was decided to start taking topographic surveys of the structure every month. These readings turned out to be extremely useful.

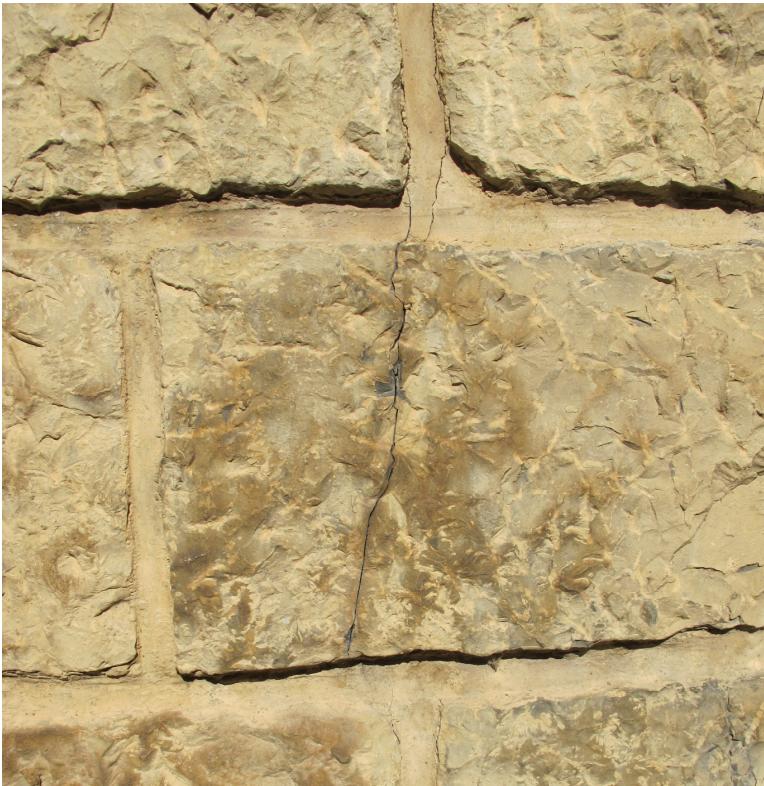
*Fig. 7 : Splitting cracks in the piers*

zone of these sections were very thin and subjected to very high stress, close to stone crushing, due to the bridge self weight. As a matter of fact, splitting cracks appeared in the following months in 4 piers, those where the kinematics of the bridge imposed the largest rotations at the base sections.

Unfortunately, during fall and winter 2011-12 the slope sliding peaked again requiring other two arcades to be propped and the most damaged piers reinforced with steel profiles and transverse prestressing so as to prevent their collapse.

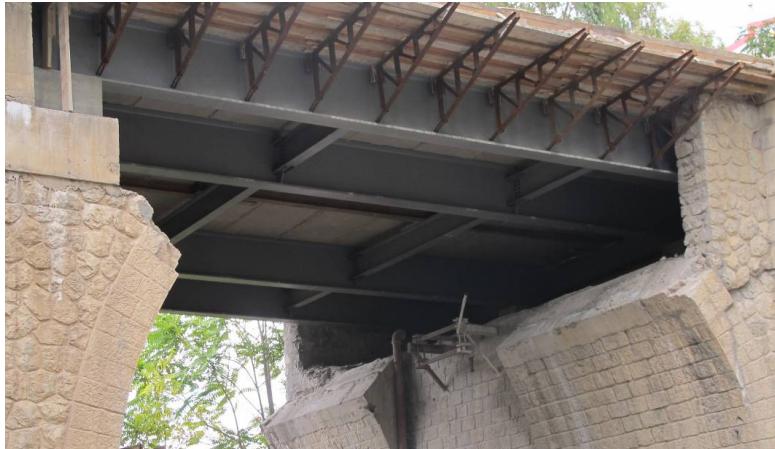
When the slope instability spiked in the '70, the first arcade connecting the abutment to the first pier had to be severed and replaced with a buffer composite span capable of absorbing the extremely high down-hill displacements of the abutment. Over the years, the joints at both sides of the buffer deck have jammed and the abutment has started to push once again against the rest of the viaduct. In 2008 the situation became dramatic, with cracks opening in the piers in the centimetre range but also with the incipient collapse of one arch.

Fig. 9 : The buffer deck between the abutment and Pier 1

The first interventions have been the temporary propping of the crushed arch in order to allow the transit of the bridge. Second intervention, in summer 2011, has been the removal of the old buffer beam that was jammed and its replacement with a new deck, shorter, lighter and with enlarged gaps to allow for differential displacement of the abutment.
